Home Inspection Report

12345 Main Street
Great City, Ohio 12345

Green Leaf Home Inspections

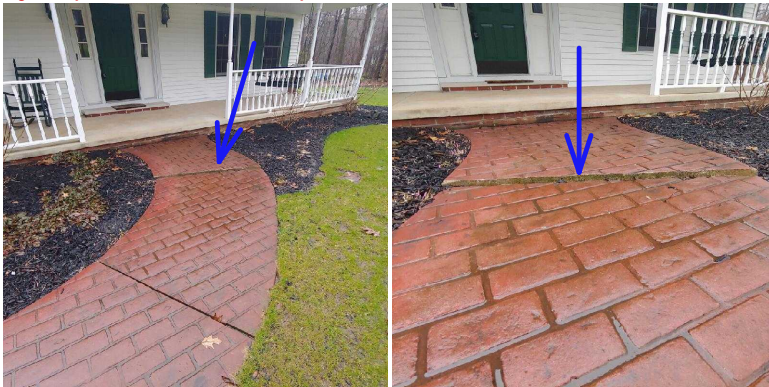
Walks: Stamped Concrete - The home's front sidewalk has settled which has created a difference in surface levels of 1" or more. Due to the trip hazard it represents, I recommend repairs/replacement by a qualified concrete professional.

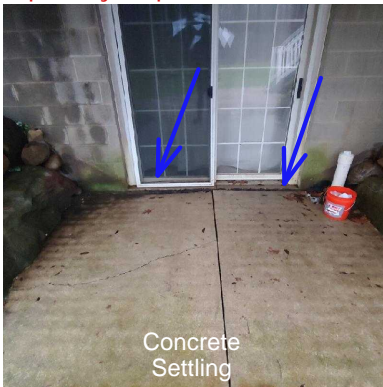
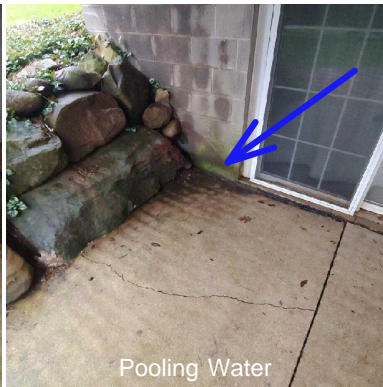
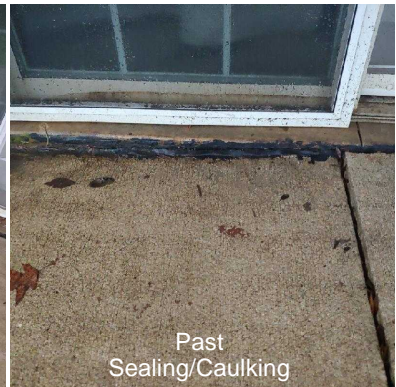
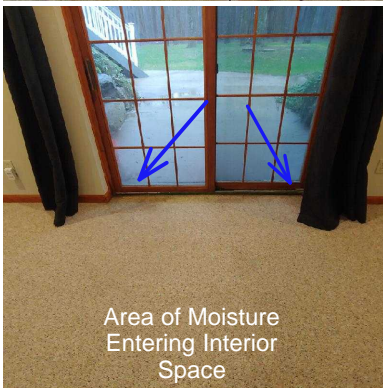
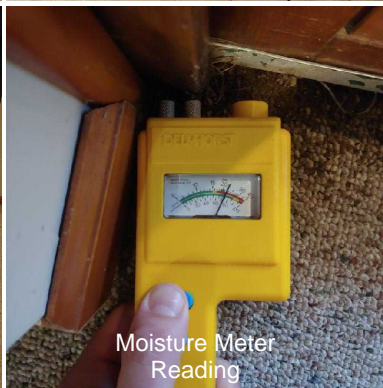
Patio/Walk-Out: The concrete pad located outside the basement walk-out has settled which is allowing moisture to actively enter under the sliding door's threshold. Moisture meter readings were taken in this area which returned elevated moisture levels. I recommend further evaluation and repair by a qualified contractor.

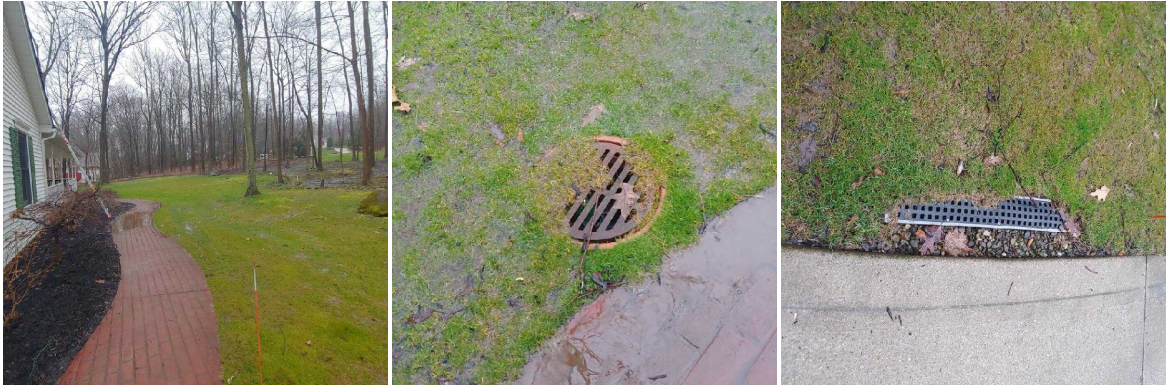
6. Marginal Grading: Negative Slope - The front lot slopes towards the home with drainage improvements noted (catch basins). The work appears to be having a positive effect in handling the run-off; however, I recommend that you inquire with the seller regarding the date and scope of the improvements. You may also wish to inquire when moisture was last an issue in the interior basement space.

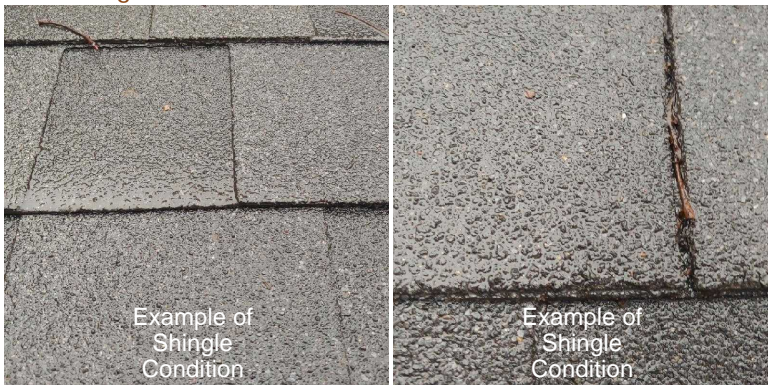
1. Method of Inspection: Ladder at Eaves & Binoculars From Ground
2. Acceptable Unable to Inspect: 0%
3. Acceptable Material: Asphalt Shingle - I observed the roof from the ground level with binoculars, as well as several sections along the eave by ladder. The shingles are in very good condition. The shingles have retained a high percentage of their protective granules and no brittle or damaged shingles were noted. I would estimate the roofing system to be 2-3 years of age with approx. 20 years of remaining useful life.

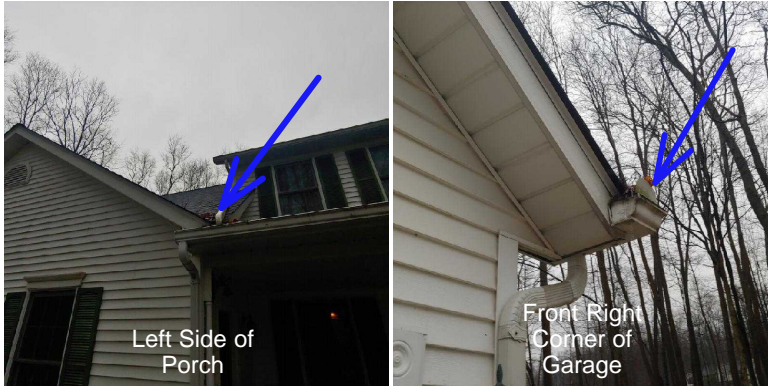
Valleys: Metal - As discussed, I recommend cleaning the two roofing valleys pictured below. These areas should be monitored going forward to ensure proper function.

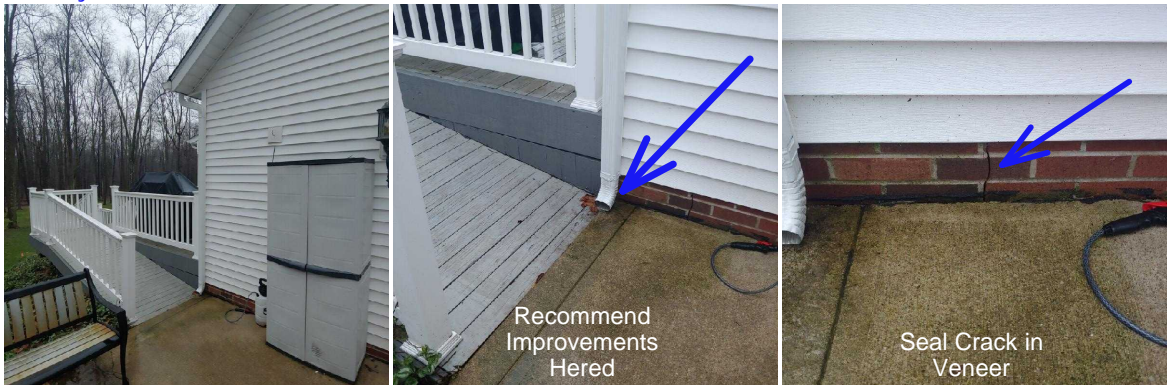
Downspouts: Aluminum - I recommend improvements to the downspout located at the rear left side of the garage. These improvements should be made so that water is no longer discharging on to the concrete/wood decking.

This issue also appears to be the root cause of the crack in the brick veneer in this area. This is not a structural concern; however, I recommend sealing/caulking the crack to prevent water from making its way behind the brick.

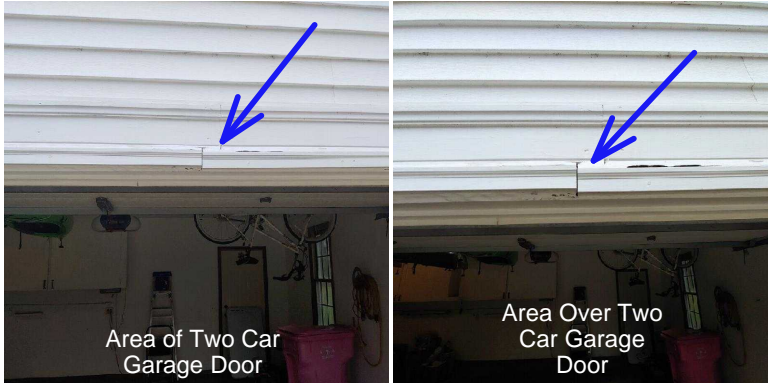
- 1. Acceptable Type: Vinyl Siding
- 2. Defective Trim: Wood - **The cut/seam in the trim located above the garage door appears to be allowing water/moisture to enter behind the trim. I recommend further evaluation and repairs by a qualified professional.**

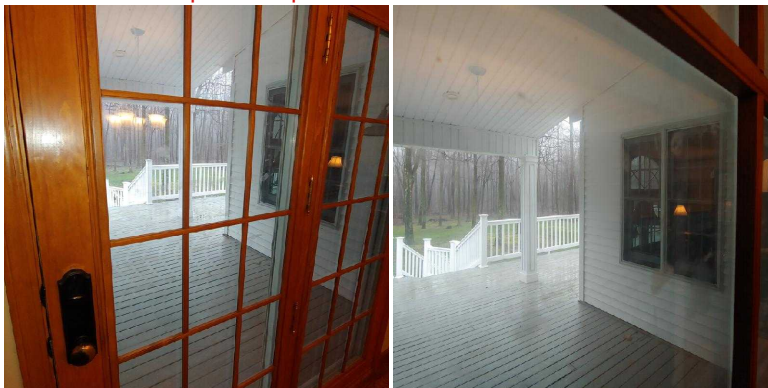
- 3. Acceptable Fascia: Aluminum
- 4. Acceptable Soffits: Aluminum
- 5. Acceptable Entry Doors: Fiberglass
- 6. Defective Patio Door: French Door - **The French door's located off the kitchen have a thermo-seal which has failed. While this is mostly a cosmetic issue, it can affect the window's energy efficiency. I recommend repairs/replacement of this item.**

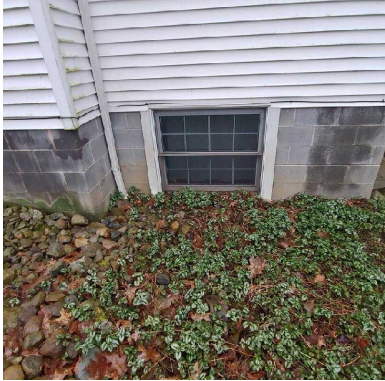
- 7. Acceptable Windows:
- 8. Acceptable Window Screens: Metal
- 9. Marginal Basement Windows: Wood Awning & Vinyl Double Hung - **As discussed, I recommend improvements so that the vegetation/soil is pulled back away from the window found at the rear right corner of the home.**

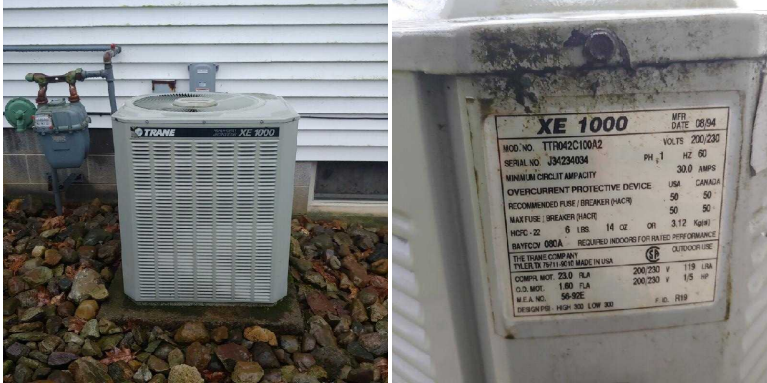
- 1. Acceptable A/C System Operation: Functional at Time of Inspection
- 2. Acceptable Condensate Removal: PVC
- 3. Marginal Exterior Unit: Pad Mounted - **While the unit functioned normally during the time of inspection, at 26 years of age, the unit has outlived its expected useful life of 20-25 years. I recommend budgeting for replacement of this item in the near future.**

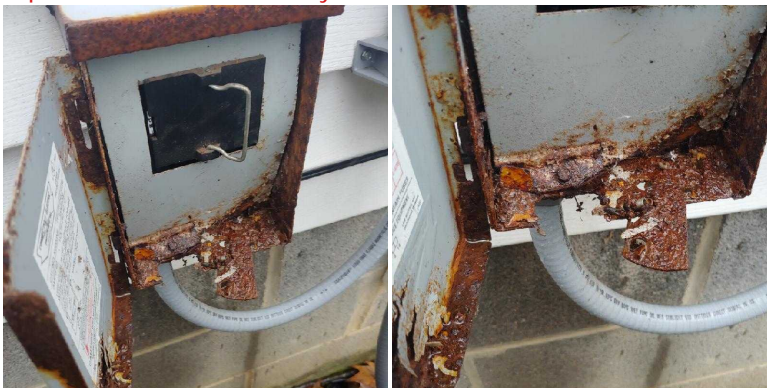
- 4. Manufacturer: Trane
- 5. Area Served: Whole Home Approximate Age: 26 Years
- 6. Fuel Type: 208-230 VAC Temperature Differential: Adequate
- 7. Type: Central A/C Capacity: 4 Ton
- 8. Acceptable Visible Coil: Aluminum
- 9. Acceptable Refrigerant Lines: Suction Line and Liquid Line
- 10. Defective Electrical Disconnect: Breaker Disconnect - **The AC compressor's disconnect box is severely corroded with active water penetration noted during the time of inspection. I recommend replacement of the box by a licensed electrician.**

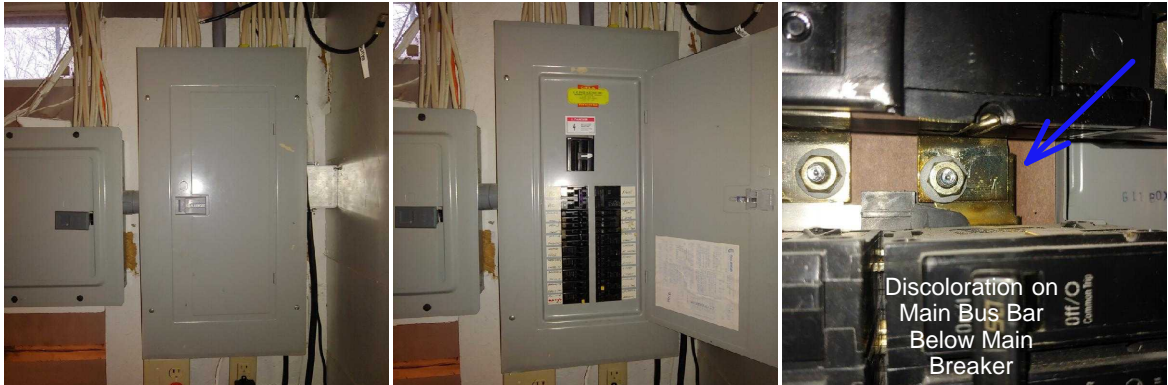
7. Defective Manufacturer: Challenger - **Discoloration was noted on the main bus bar underneath the main breaker. This issue appears to be due to overheating/scorching in this area. Further evaluation is recommended by a licensed electrician.**

Also, per our conversation, as part of this evaluation, it is also recommended that the electrician evaluates the Challenger breakers used to be sure they are free of known safety issues.

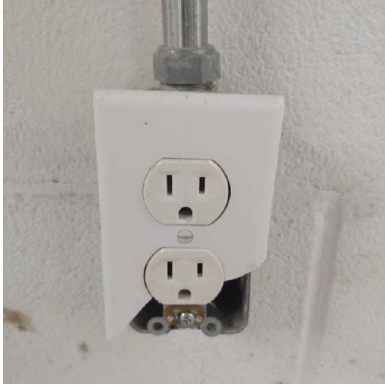
1. Not Inspected Unable to Inspect: 50% - Please note that approx. 50% of the basement walls were covered with finished drywall which prevented my visual inspection of the block foundation walls behind these areas.
2. Acceptable Ceiling: Drywall & Exposed Framing
3. Acceptable Walls: Drywall and Block
4. Acceptable Floor: Poured
5. Acceptable Floor Drain: Surface drain
6. Acceptable Doors: Vinyl Slider
7. Acceptable Windows: Wood Awning & Vinyl Double Hung
8. Marginal Electrical: 110 VAC - An electrical outlet (unfinished side of the basement - west wall) has a broken faceplate. I recommend replacing this faceplate to properly cover the wires.

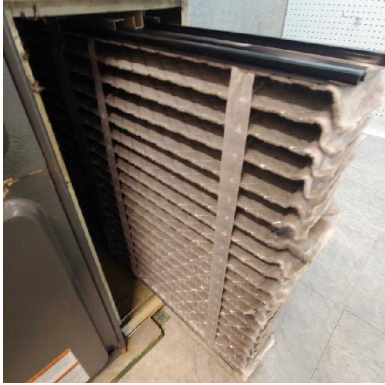
- 3. Type: Forced Air Capacity: 100,000 BTUHR
- 4. Area Served: Whole Home Approximate Age: 10 Years
- 5. Fuel Type: Natural Gas
- 6. Not Inspected Heat Exchanger: 5 Burner
- 7. Marginal Blower Fan/Filter: Direct Drive with Disposable Filter - [I recommend replacing the furnace filter. This should be done as a routine maintenance item going forward.](#)

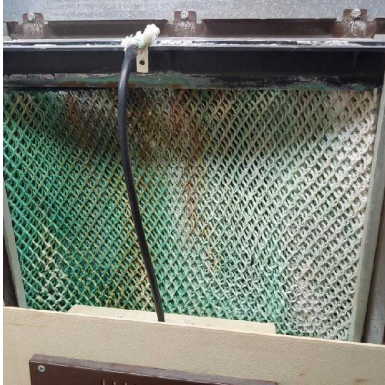
- 8. Acceptable Distribution: Metal Duct
- 9. Acceptable Draft Control: Automatic
- 10. Acceptable Flue Pipe: PVC
- 11. Acceptable Controls: Limit Switch
- 12. Not Inspected Humidifier: April-Aire - [The whole home humidifier's screen is in need of replacement.](#)

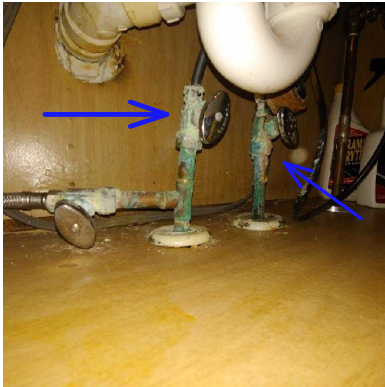
1. Acceptable Cooking Appliances: Natural Gas
2. Acceptable Disposal: Electric
3. Acceptable Dishwasher: Electric
4. Air Gap Present? Yes
5. Acceptable Refrigerator: Functioning
6. Acceptable Microwave: Funtional
7. Acceptable Sink: Stainless Steel
8. Acceptable Electrical: 110 VAC GFCI
9. Defective Plumbing/Fixtures: Stainless Steel and PVC - **The water supply line located under the kitchen sink have failed and are leaking. I recommend replacement of these fittings by a licensed plumber.**

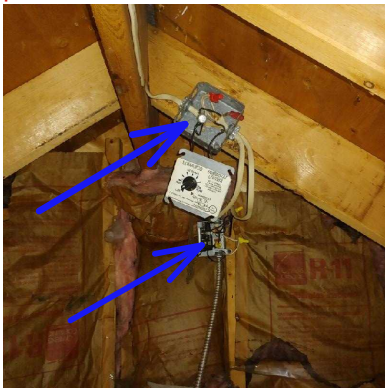
19. Defective Attic Fan: Humidistat controlled - **The wall mounted fan (south wall) has two electrical junction boxes have detached covers with exposed wires. I recommend correction of this issue by a qualified professional.**

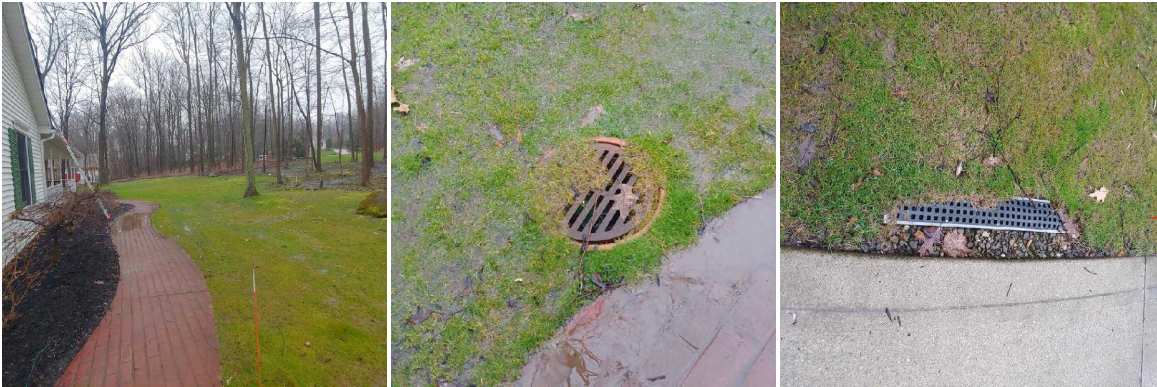
1. Grading: Negative Slope - The front lot slopes towards the home with drainage improvements noted (catch basins). The work appears to be having a positive effect in handling the run-off; however, I recommend that you inquire with the seller regarding the date and scope of the improvements. You may also wish to inquire when moisture was last an issue in the interior basement space.

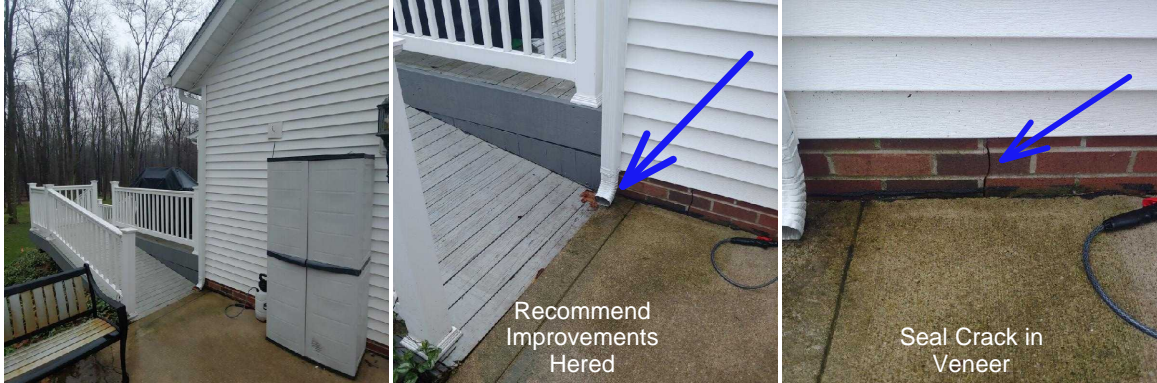
3. Gutters: Aluminum - The gutters are in need of cleaning.
4. Downspouts: Aluminum - I recommend improvements to the downspout located at the rear left side of the garage. These improvements should be made so that water is no longer discharging on to the concrete/wood decking.

This issue also appears to be the root cause of the crack in the brick veneer in this area. This is not a structural concern; however, I recommend sealing/caulking the crack to prevent water from making its way behind the brick.

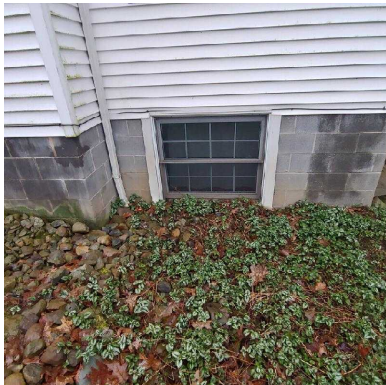
5. Basement Windows: Wood Awning & Vinyl Double Hung - As discussed, I recommend improvements so that the vegetation/soil is pulled back away from the window found at the rear right corner of the home.

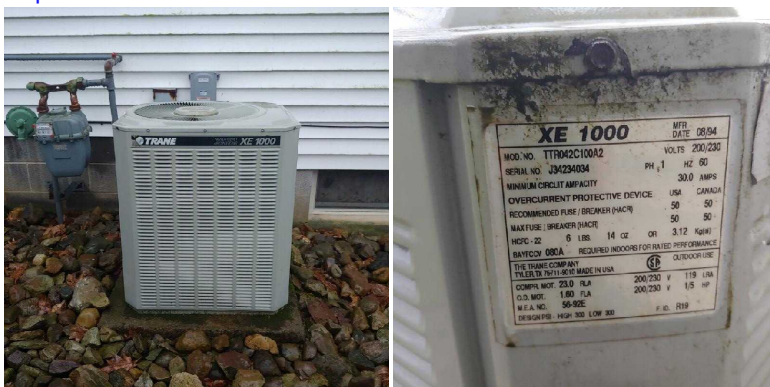
6. Main AC System Exterior Unit: Pad Mounted - While the unit functioned normally during the time of inspection, at 26 years of age, the unit has outlived its expected useful life of 20-25 years. I recommend budgeting for replacement of this item in the near future.

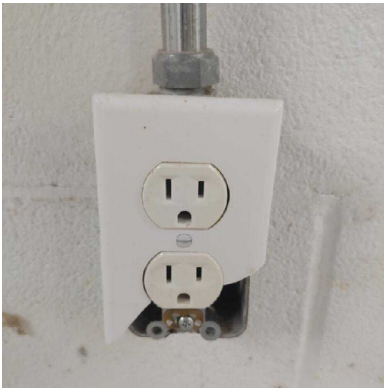
7. Main Basement Electrical: 110 VAC - An electrical outlet (unfinished side of the basement - west wall) has a broken faceplate. I recommend replacing this faceplate to properly cover the wires.

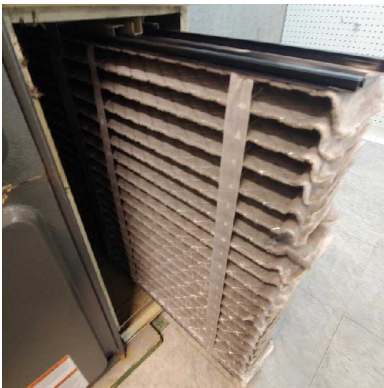
8. Basement Heating System Blower Fan/Filter: Direct Drive with Disposable Filter - I recommend replacing the furnace filter. This should be done as a routine maintenance item going forward.

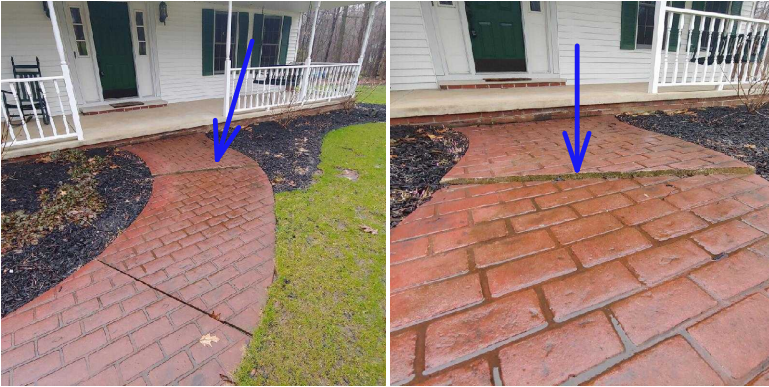
1. Walks: Stamped Concrete - The home's front sidewalk has settled which has created a difference in surface levels of 1" or more. Due to the trip hazard it represents, I recommend repairs/replacement by a qualified concrete professional.

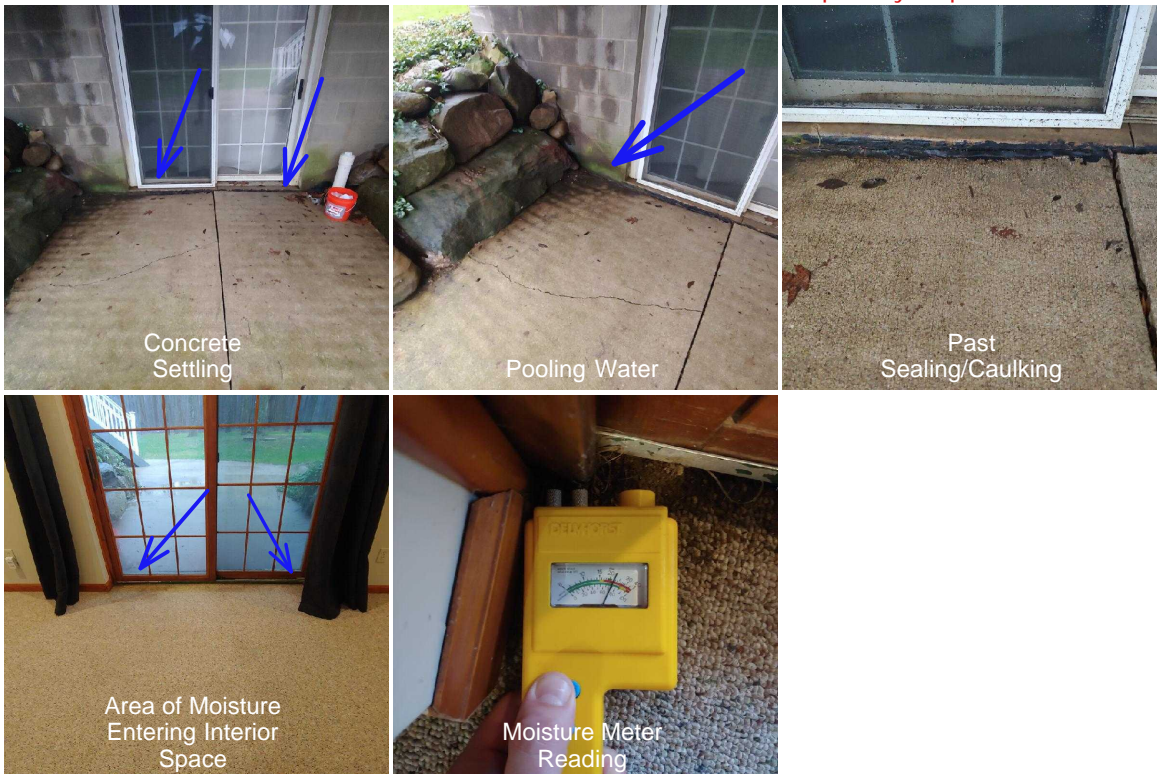
2. Patio/Walk-Out: The concrete pad located outside the basement walk-out has settled which is allowing moisture to actively enter under the sliding door's threshold. Moisture meter readings were taken in this area which returned elevated moisture levels. I recommend further evaluation and repair by a qualified contractor.

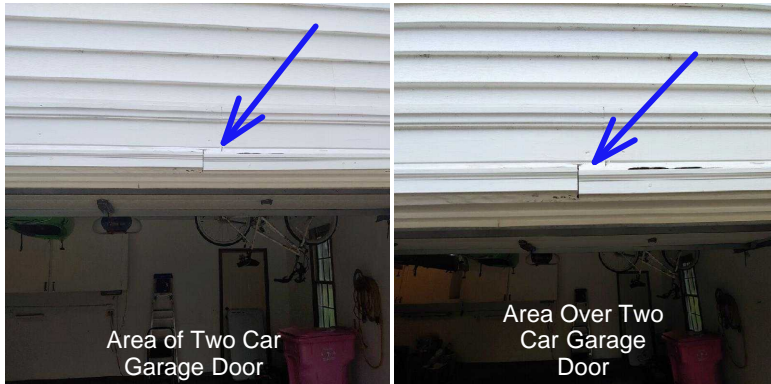
3. Trim: Wood - The cut/seam in the trim located above the garage door appears to be allowing water/moisture to enter behind the trim. I recommend further evaluation and repairs by a qualified professional.

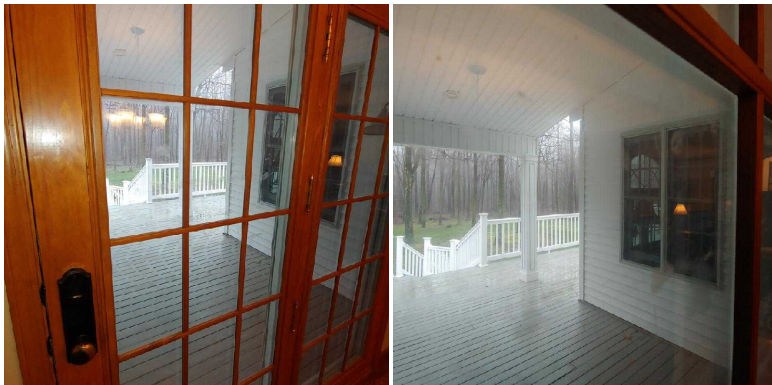
4. Patio Door: French Door - The French door's located off the kitchen have a thermo-seal which has failed. While this is mostly a cosmetic issue, it can affect the window's energy efficiency. I recommend repairs/replacement of this item.

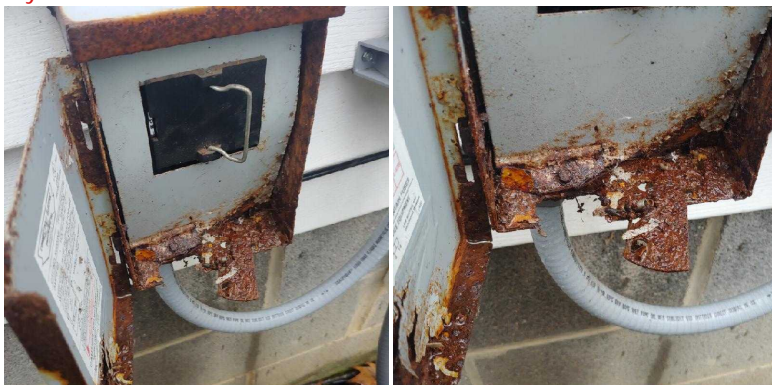
5. Main AC System Electrical Disconnect: Breaker Disconnect - The AC compressor's disconnect box is severely corroded with active water penetration noted during the time of inspection. I recommend replacement of the box by a licensed electrician.

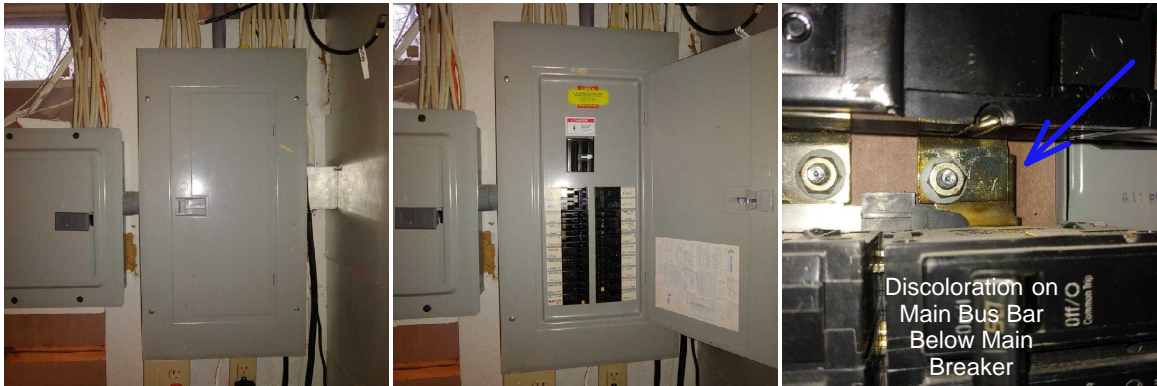
- Basement Electric Panel Manufacturer: Challenger - **Discoloration was noted on the main bus bar underneath the main breaker. This issue appears to be due to overheating/scorching in this area. Further evaluation is recommended by a licensed electrician.**

Also, per our conversation, as part of this evaluation, it is also recommended that the electrician evaluates the Challenger breakers used to be sure they are free of known safety issues.

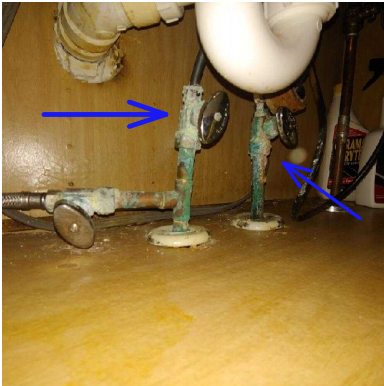
- 1st Floor Kitchen Plumbing/Fixtures: Stainless Steel and PVC - **The water supply line located under the kitchen sink have failed and are leaking. I recommend replacement of these fittings by a licensed plumber.**

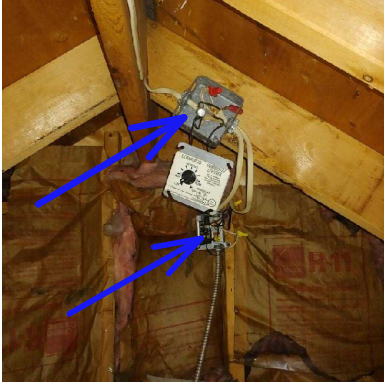
- Walk-In Attic Space Attic Attic Fan: Humidistat controlled - **The wall mounted fan (south wall) has two electrical junction boxes have detached covers with exposed wires. I recommend correction of this issue by a qualified professional.**
