Home Inspection Report

123 ABC Lane
Chagrin Falls, Ohio 44023

Green Leaf Home Inspections

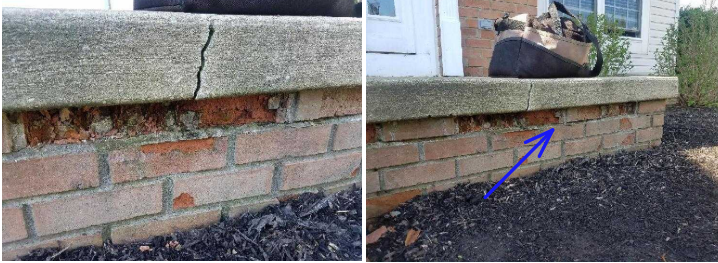
Acceptable Driveway: Asphalt
Acceptable Walks: Concrete
Marginal Steps/Stoops: Concrete with brick foundation walls. [Spalling brick on front stoop. Recommend a qualified masonry repair to prevent further damage/water intrusion.](#)

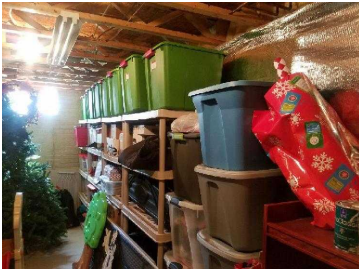
Not Inspected Unable to Inspect: 65% - Storage and finished walls prevented full inspection of foundation walls from inside the basement.

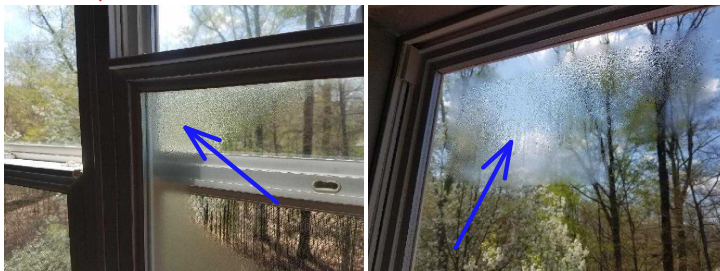
Acceptable Closet: Walk In
Acceptable Ceiling: Drywall
Acceptable Walls: Drywall
Acceptable Floor: Ceramic tile
Acceptable Doors: Hollow wood
Defective Windows: Vinyl double hung - **Three seals have failed (top left, and both the bottom and top of right window) in master bath window**

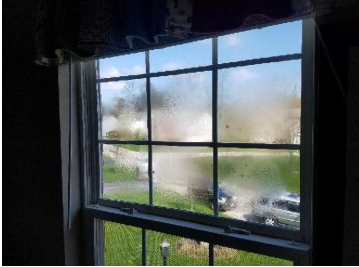
Acceptable Floor: Carpet
Acceptable Doors: Hollow wood
Defective Windows: Vinyl double hung - **Window seal has failed**

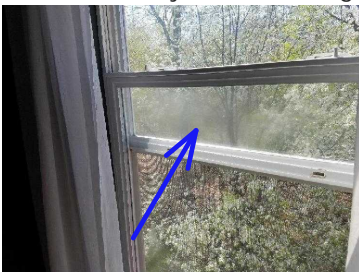
Acceptable Closet: Walk In
Acceptable Ceiling: Drywall
Acceptable Walls: Drywall
Acceptable Floor: Carpet
Acceptable Doors: Hollow wood
Defective Windows: Vinyl double hung - **Window seal has failed**

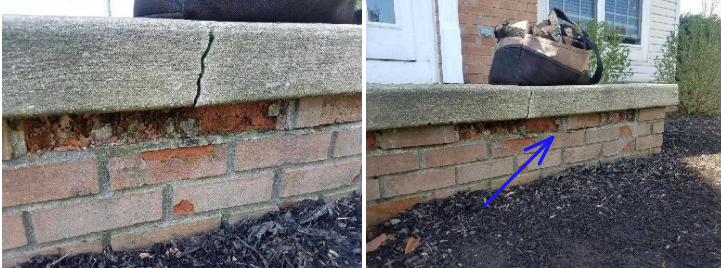
1. Steps/Stoops: Concrete with brick foundation walls. [Spalling brick on front stoop. Recommend a qualified masonry repair to prevent further damage/water intrusion.](#)

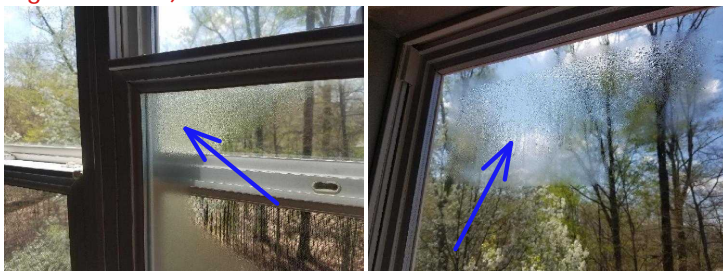
5. Master Bathroom Windows: Vinyl double hung - **Three seals have failed (top left, and both the bottom and top of right window) in master bath window**

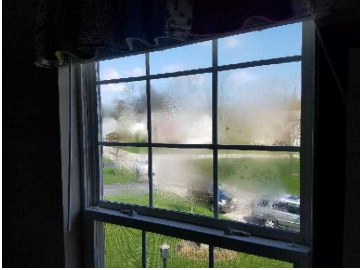
6. 2nd Floor Left Front Bedroom Windows: Vinyl double hung - **Window seal has failed**

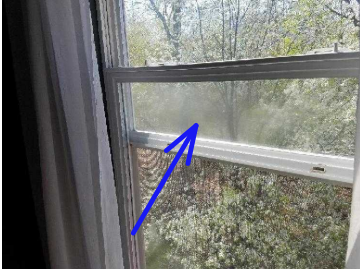
7. Master Bedroom Windows: Vinyl double hung - **Window seal has failed**
