Home Inspection Report

12345 Main Street
Great City, Ohio 12345

Green Leaf Home Inspections

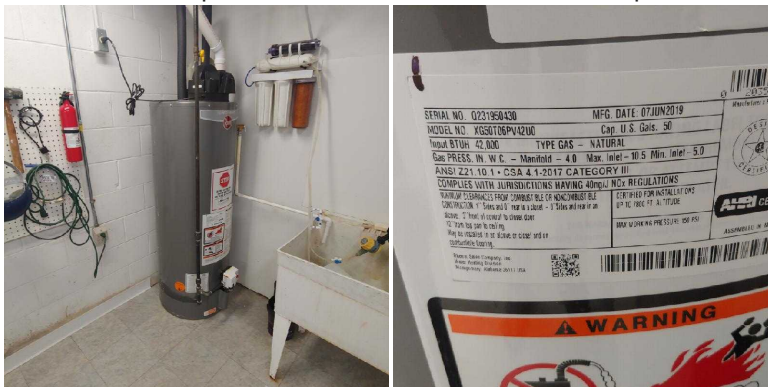
8. Manufacturer: Rheem
9. Type: Natural Gas Capacity: 50 Gal.
10. Approximate Age: 1 Year Area Served: Whole Home
11. Acceptable Flue Pipe: PVC
12. Acceptable TPRV and Drain Tube: PVC

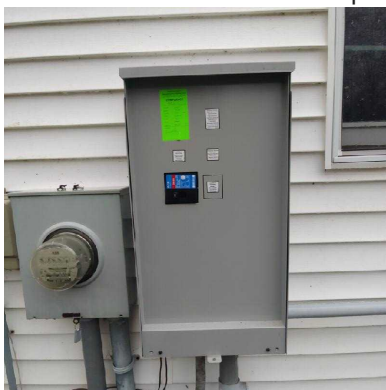
8. Maximum Capacity: 200 Amps
9. Acceptable Main Breaker Size: 200 Amps - Main service disconnect located at side of home (200 Amp).

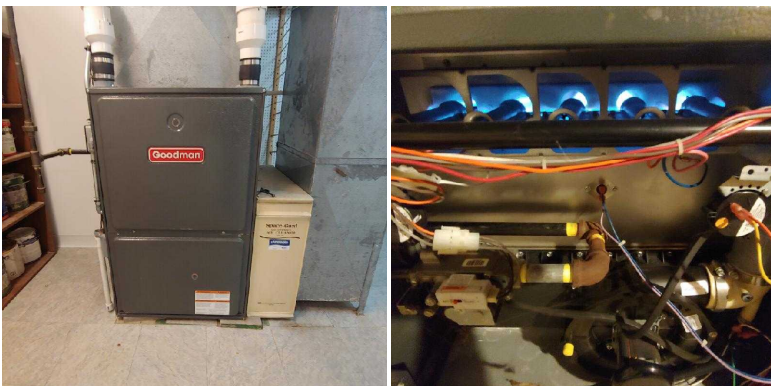
1. Acceptable Heating System Operation: Functional at the Time of Inspection
2. Manufacturer: Goodman

- 3. Type: Forced Air Capacity: 100,000 BTUHR
- 4. Area Served: Whole Home Approximate Age: 10 Years
- 5. Fuel Type: Natural Gas
- 6. Not Inspected Heat Exchanger: 5 Burner
- 7. Marginal Blower Fan/Filter: Direct Drive with Disposable Filter - [I recommend replacing the furnace filter. This should be done as a routine maintenance item going forward.](#)

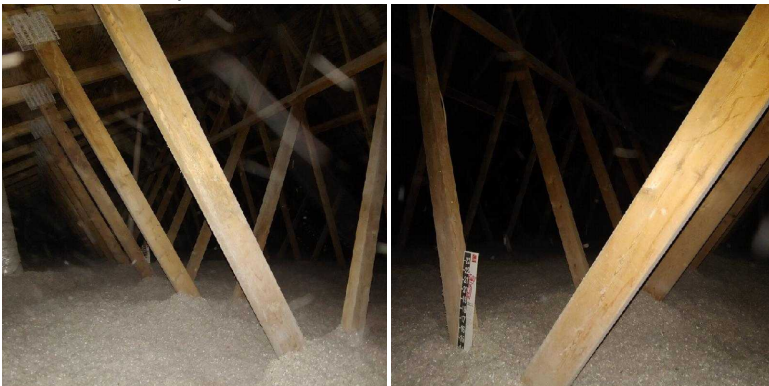
2. Acceptable Unable to Inspect: 0%
3. Acceptable Roof Framing: 2x4 Truss
4. Acceptable Sheathing: Plywood
5. Acceptable Ventilation: Soffit and Ridge Vents
6. Acceptable Insulation: Blown in

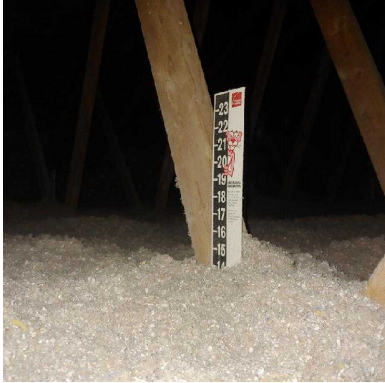
7. Acceptable Insulation Depth: 14"
